KAY-LINN

CASPER MOUNTAIN PARKS TRAIL SYSTEM ASSESSMENT & CONCEPTUAL PLAN (10/2014)

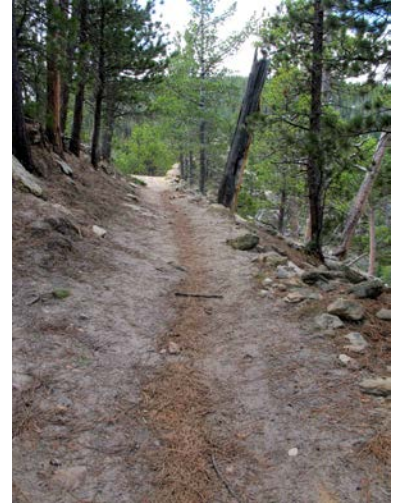
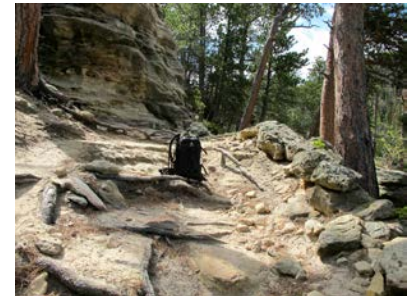
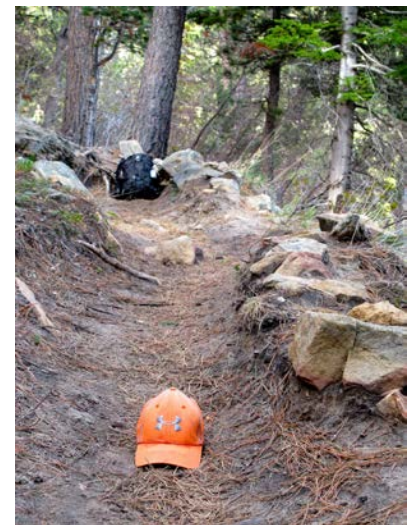
- Intense social trail development down to overlooks of falls.
- Considerable amount of intact, historic rock crib walls across entire loop.
- Dimensional lumber/t-stake/heavy gauge wire retaining walls and wooden steps installed much more recently than rock walls and in degraded condition or demonstrating signs of stress (bowed walls, exposed rebar)

- Significant formalization needed to provide a consistent experience befitting of the location of the trail and to deter continued social trail use.
- Water management structures at 50-75' intervals or where possible throughout entire trail, especially on steep western leg, and all areas where 15%+ grades continue for more than 50', focusing on water management at the upper edge of the steep gradient and where the trail turns into the hillslope.
- Remove lumber-based cribwalls and replace with rock to match WPA construction aesthetic.
- Add rock steps on all fall-line trail sections at grades of 15% and above to maintain narrow trail. Steps should not require more than a 12" rise to continue to provide maximum access to the trail.
-

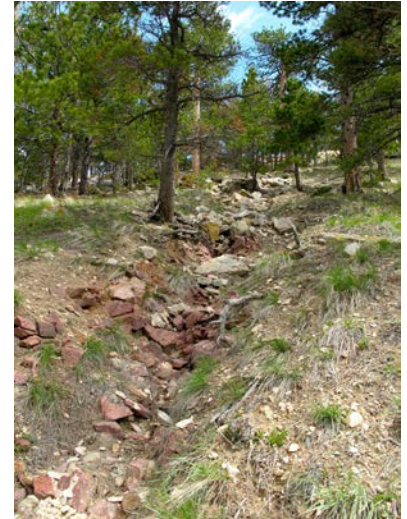
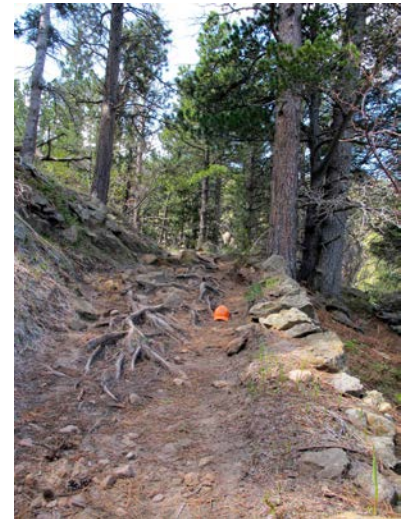
- Originally constructed 4- 6' wide trail, with backslope sloughing resulting in 2-4' active trail tread.
- Very limited presence of water management on entire system of trails.
- Some rolling contour sections with grades less than 10% have held up quite well.
- Moderate to heavy erosion throughout the majority of the trails, which has led to the removal of much of the fill material behind rock retaining walls and washed down to bedrock in many locations. Most of the trail has lost between 4" and 2' of tread material.
- For the most part, the original rock walls are still intact.
- Shortcutting of stacked switchbacks is occurring.
- Similar trail closure styles at private property junctions to Lower Cutoff.

- Significant formalization needed to provide a consistent experience befitting of the location of the trail and to deter continued social trail use.
- Water management structures at 50-75' intervals or where possible throughout entire trail and all areas where 15%+ grades continue for more than 50', focusing on water management at the upper edge of the steep gradient and where the trail turns into the hillslope.
- Remove lumber-based cribwalls and replace with rock to match WPA construction aesthetic.
- Refill material behind rock retaining walls and combine with rock steps to reconstruct and "save" this extensive, high-quality construction.

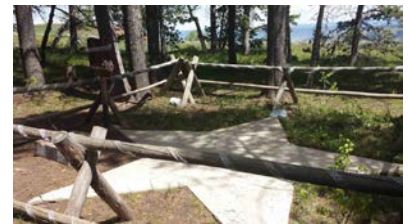
- Unsigned access to the Woodland Trail originates from the eastern and western ends of the parking area along the historic farm route that is now barely discernible.
- Access is also possible adjacent to the museum, again without signs.
- The trail is approximately 15' wide throughout its course through the shrines and to the woodland theatre, before connecting to the old farm route just outside the forest at the eastern and western ends of the loop.
- Trail grades are very mellow, less than 5%, over the entire loop.
- The tread surface is not improved and the edges of the trail are continually lined with logs, ostensibly to contain traffic during the busy Midsummer Festival.
- Rustic fences encircle each shrine and separate these areas from the trail.
- Each of the shrines has an interpretive description of its contents.
- Most of the shrines are in a degraded condition.

- Develop Trailhead kiosk with thematic map.
- Consider reconstruction of the existing trail route, creating 6'-wide, aggregate surfaced trail that meets accessibility guidelines.
- Continue with the existing, mandated (by Crimson Dawn Society) theme in park, but make modern upgrades to interpretation.
- Add a narrow, natural surface loop trail of approximately 1-mile to the north of the existing infrastructure and connecting to the Cemetery Trail to broaden the recreational opportunities.

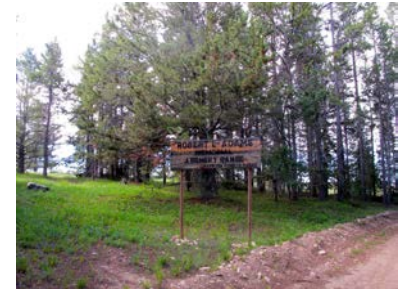
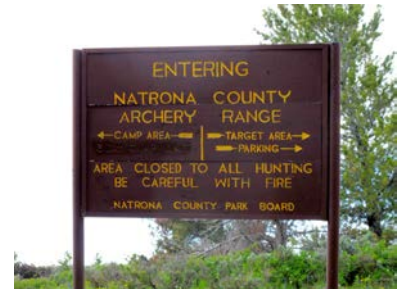
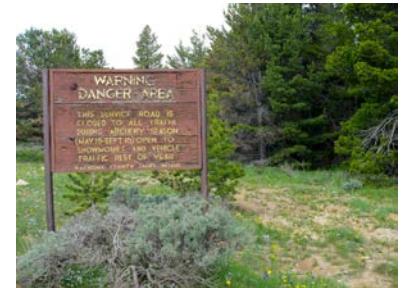
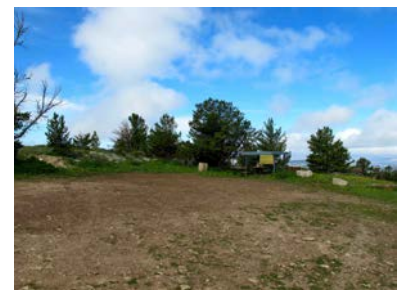
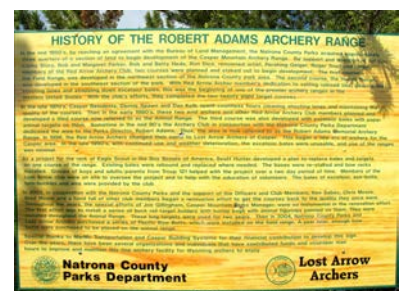
- Signage directing visitors to Park is of dissimilar size and visibility, hindering navigation from County Road 504 to Micro Road and Archery Range road and the park.
- Safety berms and signage present along entrance road, but main safety sign is heavily degraded and is the only readily apparent safety-related messaging.
- A kiosk exists behind the covered pavilion explaining the history of the archery-focused park.
- No trail/range map exists.
- Small signs indicate entrances to Target and Animal Range trails.
- Mobility-impaired access at main facility is adequate, but could be improved, especially for access to the practice range.

- Improve size and quality of navigation signage along roads.
- Institute a comprehensive safety signage program at park entrance and parking area.
- Develop course map signage in kiosk and paper forms. Paper maps could also include scoring tabs.
- Improve accessibility at the trailhead and practice range area.
- Develop an additional, 14-target course in the southwest portion of the property that focuses on children and newcomers to the sport with instructional interpretation, shorter target distances, and larger targets.
- Better manage stormwater flows from parking area.
- Add rolling grade dips at 50-75' intervals on entrance trail to target range.

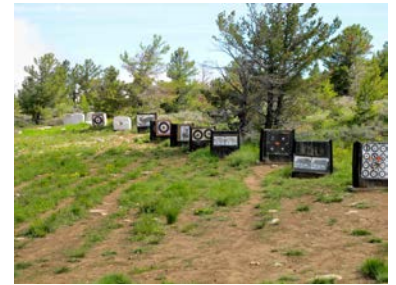
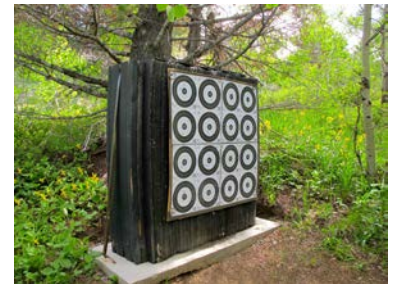
- Stormwater runoff from parking area drains down main trail to target range, causing significant erosion on the trail to the first target as well as the cutoff trail to target twenty eight.
- The course is well-marked, with distance markers intact and targets in good working order.
- Each hole has a rest/wait bench that are aging but not yet degraded.
- Shooting corridors are quite narrow with some branches intruding into the shooting corridor.
- Some trails between targets are oriented on the fall line of the hillslope and are showing minor signs of degradation, which would worsen with increased use.
- Targets do not have earthen berms to contain arrow flight, nor is vegetation cleared behind targets to facilitate arrow recovery. However, with such a tight course this situation provides some measure of safety.

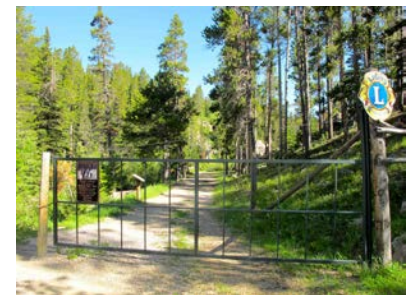
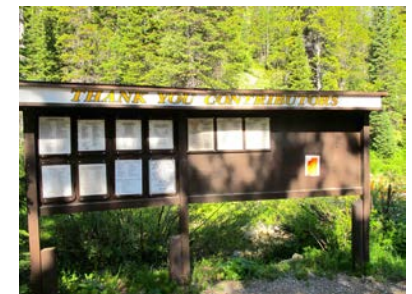
- The trailhead area has a number of kiosks, mostly dedicated to listing and thanking individual and group contributors to the original and numerous reconstructions of the trail. A small handwritten sign states that the trail is currently closed, ostensibly the reason for the closed gate.
- A closed cabinet contains a guest log and trifold brochure that provides a history and photos of the trail development.
- No maps of the trail are present.
- The trail is made accessible to those with visual impairment by use of wood posts spaced at approximately fifteen-foot intervals with a small rope strung between the posts at approximately three feet off the ground.
- Most of the posts are anchored firmly, but a few wobble a few inches if pushed.
- Thirty four interpretive signs are present along the trail, some as close as six linear feet and others separated by more than 150 feet.

- Formalize parking area along Strube Loop with a sign and improved delineation of parking or restore area to natural forest cover.
- Add trail map to kiosk area in flat and raised topographic formats.
- Consider removal of extensive “thank you” kiosks and replace with a general kiosk giving thanks, providing history, and explaining park regulations.
- Remove protrusions from trail tread.
- Endeavor to improve trail to modern accessibility standards in width, grade, and level of roughness.
- Consider a reduction in the number of interpretive stations along trail, combining multiple ecological messages in a single sign. Consider the addition of vision impairment and Braille interpretation for sighted trail users.

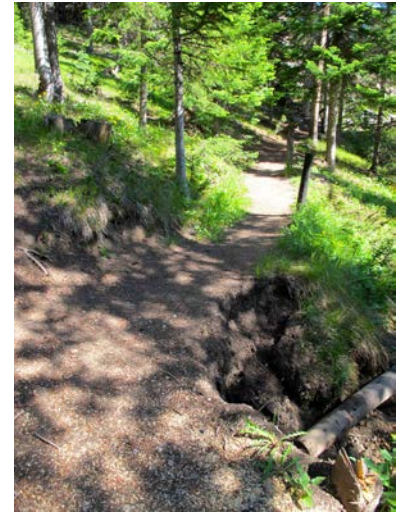
- The trail tread is a combination of natural dirt surface with many areas of added aggregate material to maintain tread firmness and stability. A number of rocks protrude one to three inches above the trail tread along its course, especially in steeper trail grades and switchbacks.
- Very little outslope is present to maintain a flat trail tread.
- The tread ranges in width from two to four feet.
- Trail grades range from flat to greater than 20%.
- Near the beginning of the trail a recent tree blow down has led to post/rope break and an approximately six-foot long slough that intrudes a number of inches into the trail tread.

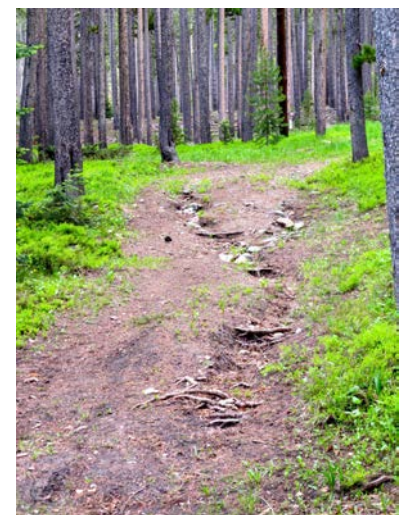
- Trail corridors are often quite narrow, sometimes too narrow for many modern mountain bike handlebars.
- Much of the trail is adequately constructed with trail grades ranging from flat to 15%. However, multiple alignments on the fall line of the hillslope are beginning to show signs of degradation caused by water running down the trail, tires lost traction, or braking forces.

- Mountain biking-specific structures have been erected, log pyramids and berms with a pine and/or plywood foundation. A few of these structures are rapidly degrading due to poor construction techniques.

- Redevelop, sign, and map the snowshoe/singletrack trail system to minimize intersections with the nordic trail system to eliminate shared-use issues related to grooming and trail quality in the winter and navigation and hiking experiential quality in the summer.

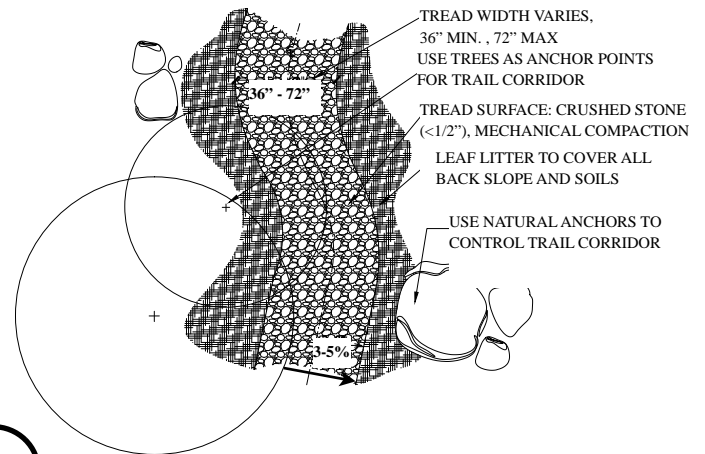
1.1

PLAN DETAIL: GREENWAY TRAIL TYP.

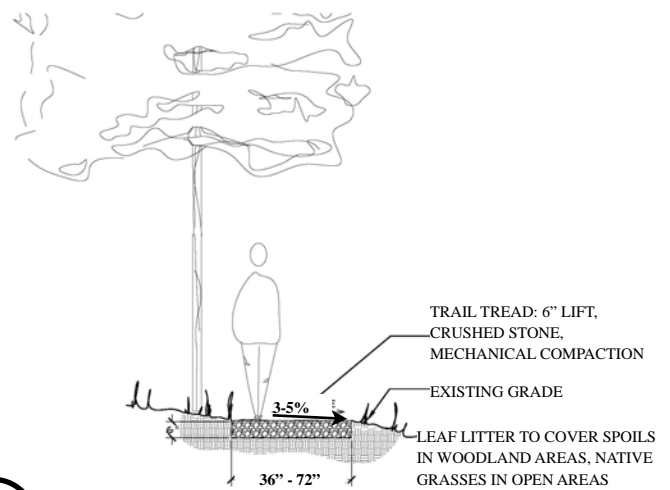
1.2

SECTION DETAIL: GREENWAY TRAIL TYP.

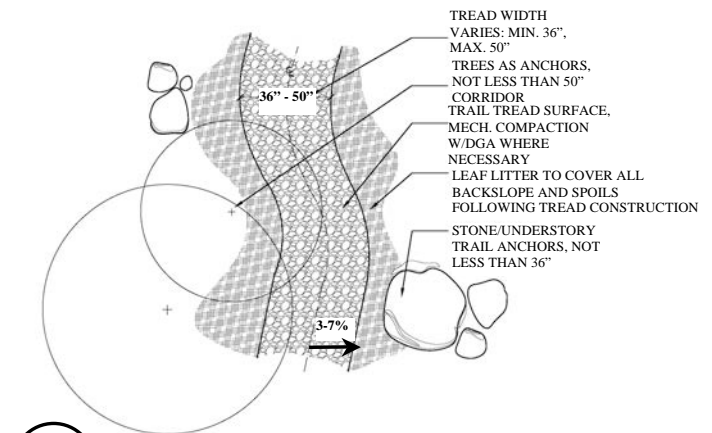
PLAN DETAIL: FRONTCOUNTRY TRAIL- TYP.

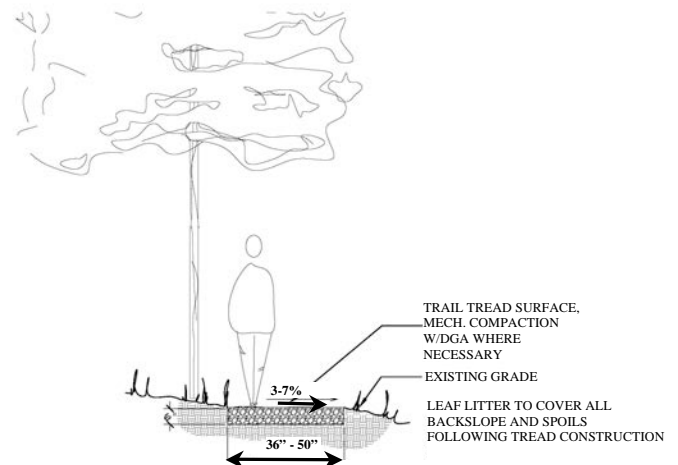
SECTION DETAIL: FRONTCOUNTRY TRAIL- TYP.

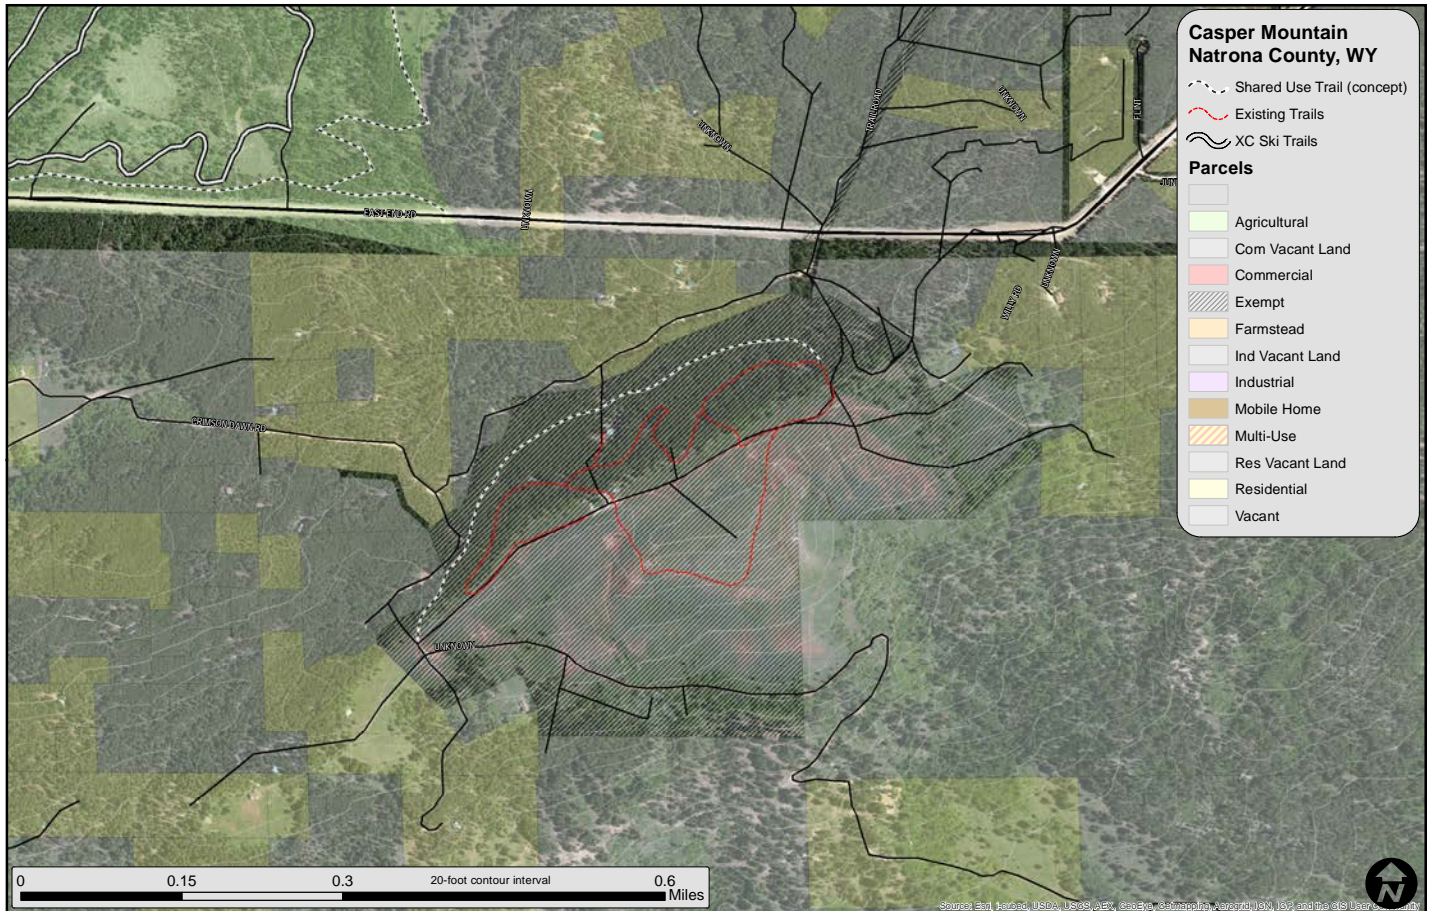
CONCEPTUAL TRAIL SYSTEM

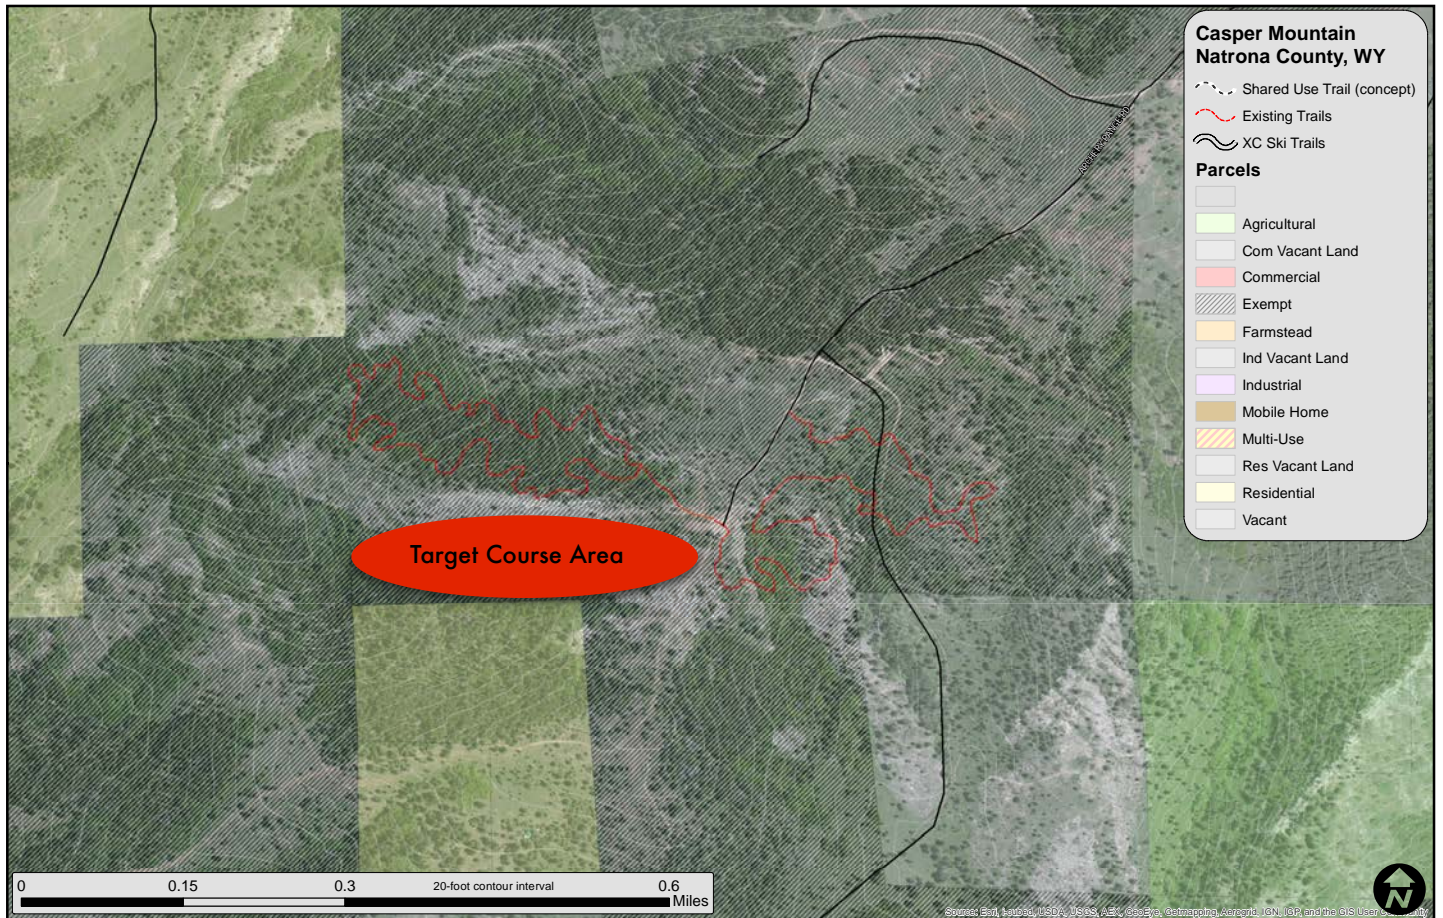
CONCEPTUAL RECREATION IMPROVEMENT- ADDITIONAL TARGET COURSE

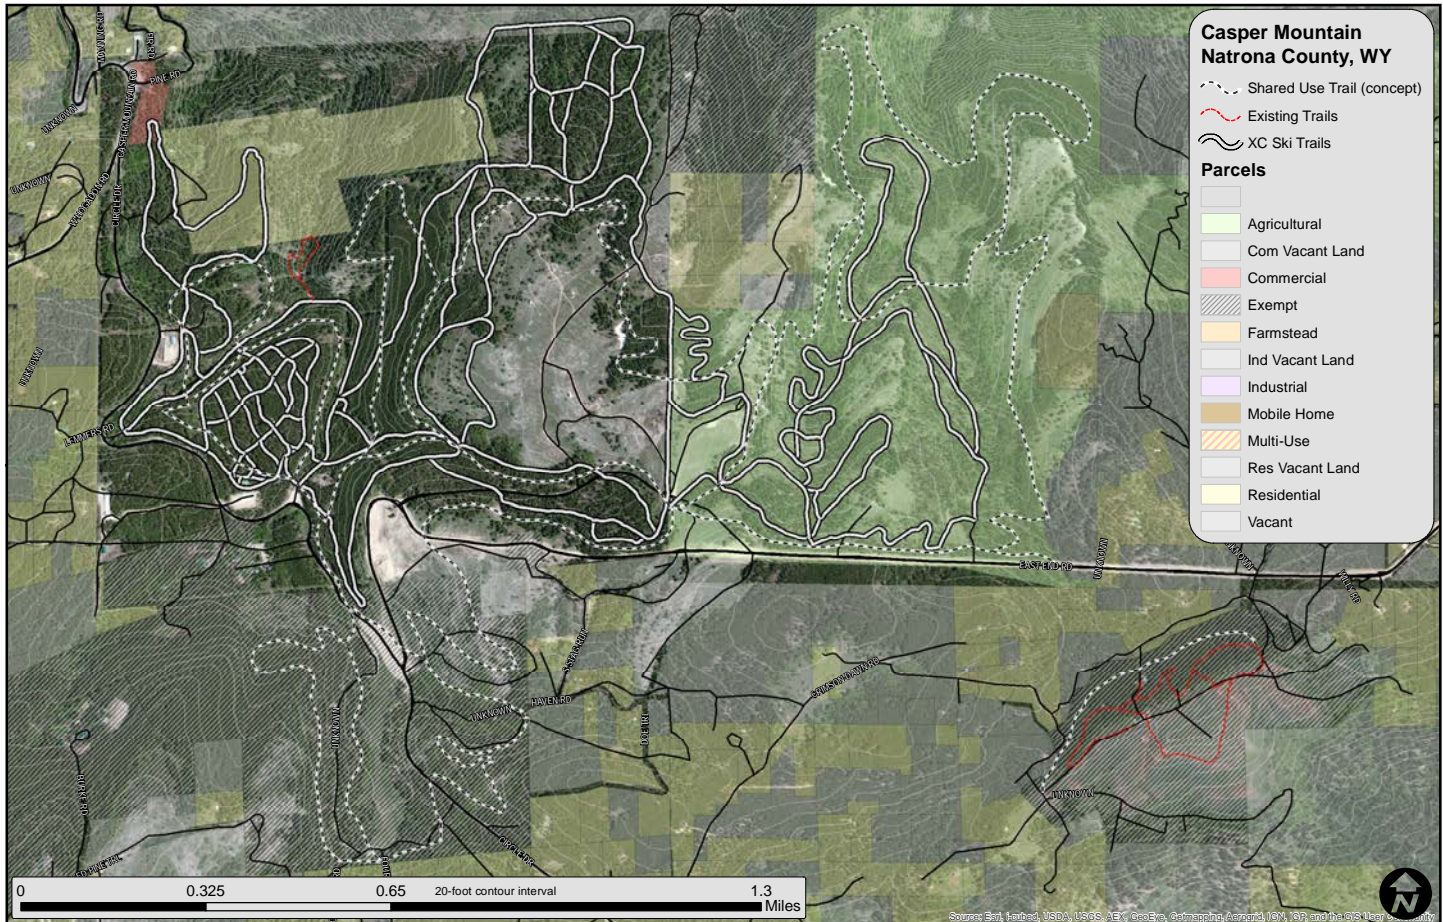
CONCEPTUAL TRAIL SYSTEM

- Two major existing parking area/trailheads- CMTC and Beartrap Meadows
- Secondary trailheads with trailhead kiosk only (no additional parking) to be developed at campground interface locations
- Minimized intersections with the existing Nordic trail network
- Frontcountry trail system of approximately 5 miles that provides short loops with multiple route options and trail access from CMTC and all area campgrounds. Potential for expansion if area landowners are amenable.
- Backcountry trail system of approximately 7 miles made of larger loops with multiple route options, with access to the planned biathlon center. Potential for expansion if area landowners are amenable.
- Recommendation for new trails to be managed as mountain bike-optimized, shared-use in Summer and snowshoe/snow bike/dog walking trails in the Winter

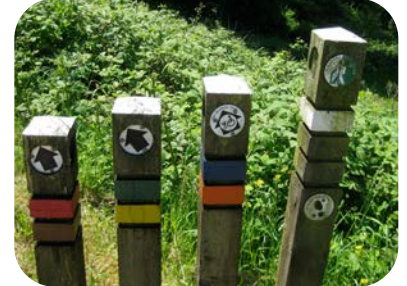
Roadside Signs

A positive experience on a trail begins by easily finding the desired location, be it a developed trailhead, boat launch, or brick and mortar facility. This gross level navigation requires roadside signage prior to the developed facility. With a suite of facilities as broad and diverse as those present on the Casper Mountain, a universal symbol should be combined with short verbiage and mileage to provide information that can be recognized and comprehended at driving speeds. These clear, roadside signs help encourage trail use and dissuade visitors from creating unauthorized access routes.

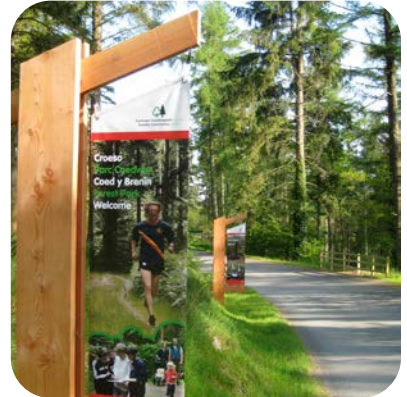
Trailhead Signs

Upon entering a developed trailhead facility, large signs with a complete map and description of all the nearby trails and facilities, local regulations, emergency contact information, and educational messages should be located to funnel visitors to the developed facilities such as rest rooms, trails, launch, etc. This main trailhead kiosk is an ideal place to describe trail length and relative difficulty, allowing visitors to make informed decisions about their recreational experience. Trailhead kiosks can incorporate interpretive, programming, volunteer, and printed information such as maps. The total amount of information provided should mesh with the level of facility development. Major trailheads with significant parking should creatively incorporate most information, while striving not to reach “information overload”, while smaller trailheads may only require a map board (with location), emergency contact, and basic regulations.

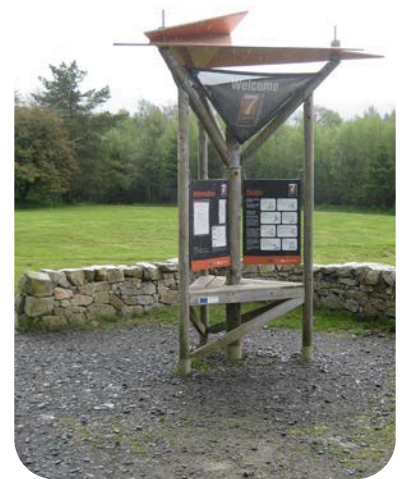
Trailside Signs

Signs at trail intersections should provide clear, concise directions for how to stay on the trail or return to a trailhead. This navigation assistance is best provided on wooden or fiberglass posts at heights easily read by trail users, typically 60 – 84 inches from ground level, with standard iconography for allowed uses and difficulty level. Intersection signs can post location identification information to aid in emergencies. Outside of trail intersections, little signage is required on trails. Longer trails may necessitate waymarking, “confidence” signage, also placed on posts with location information.

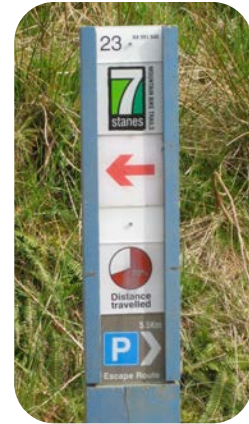
Regulatory And Warning Signs

Human management of delineated rules will be difficult except in spot locations. While it is simple to list dozens of prohibited activities, the success of regulatory signage is usually dictated by its practicality, ease of comprehension, and attitude. Fewer, more practical rules and explanations about why regulations are present almost always achieve higher compliance rates. Images and short phrases are much easier for a broader segment of the public to take note and understand. Positive phrasing of rules engenders a spirit of cooperative management with the public.

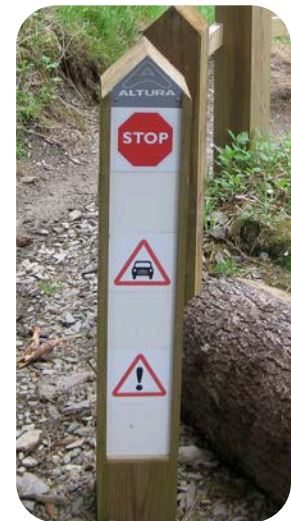
Warning Signs

Signs play a vital role in managing risk. These signs alert the public to known hazards and the potential hazards of changing environmental conditions. When appropriate, warning signs should be used to mark known hazards. Position them well in advance of the hazard or risk so that visitors have enough time to read the sign and react. Also consider adding signs before unexpected challenging technical trail features, like drop-offs, narrow bridges, or other elements of increased risk. Where human-vehicle interactions will occur, traditional yield signs, painted crosswalks, stop signs and traffic signals are necessary. Along the trail approaching a road crossing, both “slow” and “stop” signs should be considered. Additionally, consider placing information signs, such as trail name and allowed uses, on either side of a road crossing, as these are trail-system access points.
